Software Update 2009-1

Release Notes

These are the Release Notes for the January 2009 GreenStar™ 2 Display 2600 software version 2.3.1385 and the Original GreenStar display software version 1.95H.

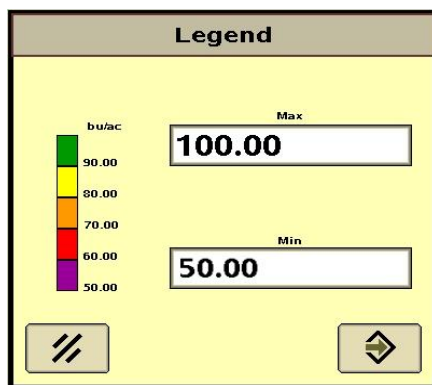
Past Software

Legend range is misleading

Previous Software: The legend minimum and maximum represented the smallest and largest values displayed. Values below or above these ranges were not very clear.

Software Update 2009-1: The legend range is more clearly defined

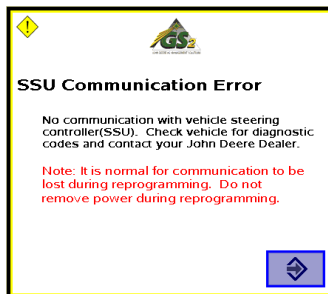
SSU Alert during reprogramming of AutoTrac™ Universal

Previous Software: During the reprogramming of an ATU, an SSU alert would appear informing the user that communication has been lost. Commonly, an operator would remove power causing problems to the reprogramming process.

Software Update 2009-1: The below alert below message provides further direction.

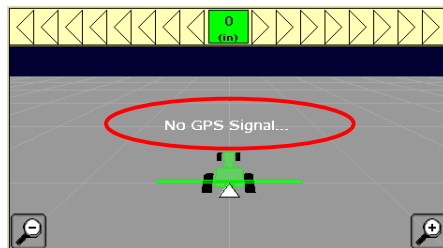
GPS not read correctly from an Original StarFire™

Previous Software: The GS2 display may have displayed “No GPS” when connected to a GEN2 receiver, even though the Original GreenStar display would show good GPS signal.

Software Update 2009-1: Fixed

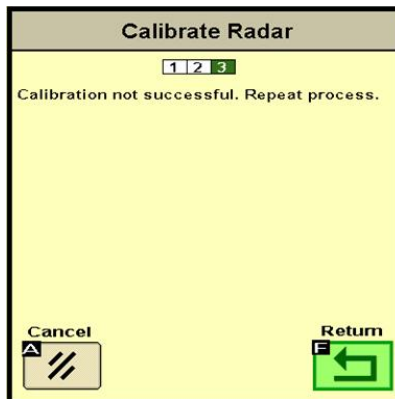
Radar Calibration Issue – During radar calibration on John Deere machines including (00, 10, and 20 series tractors) and (00 and 10 series sprayers) if equipped, the “*Calibration not successful. Repeat process.*” message will appear even when the calibration was successful. This means there is no indicator at this time of whether your calibration was successful on these machines. We are working to resolve this issue.

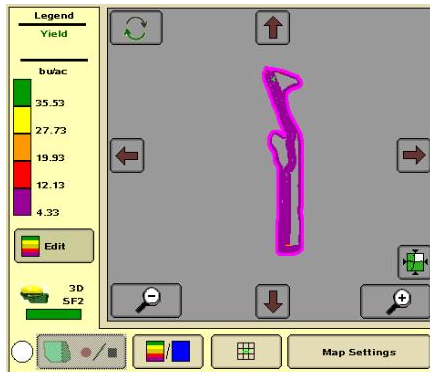
Before Cold Boot

After a cold boot of the display, the coverage map in overhead mapping view isn't displayed - If an operator has a coverage map of a field, with or without a boundary, and uses the overhead mapping view of the field after performing a cold boot of the display the boundary will only be displayed with no coverage map. Simply engage recording and the coverage map will reappear.

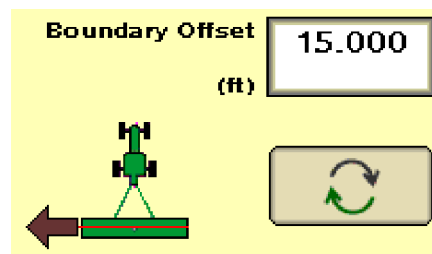
Boundary recording position "indication icon" is misleading - On the Boundaries tab, when toggling through the various machine and implement boundary recording positions, the red line doesn't correctly indicate where recording is occurring. For example, in the image below, the boundary is being recorded from the left side of the rear of the implement opposed to the middle of the implement where the red line indicates.

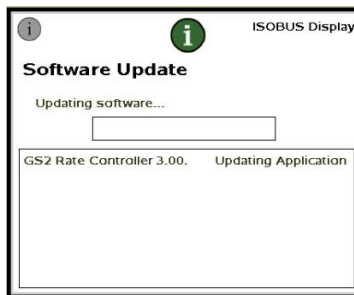
Inactive status bar when reprogramming a GS2 Rate Controller - When reprogramming a rate controller it is possible that the status bar will not update correctly and appear unresponsive even though the controller is updating. It is advised to wait 10 minutes before cycling power. The GS2 Rate Controller softkey will be available on the menu page when the reprogramming is complete.

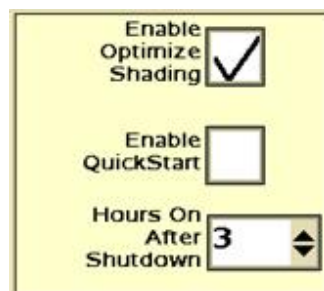
Enable Optimize Shading - Prior to the release of this software the "Enable Optimize Shading" feature was defaulted to "off" and unchecked. In current software, "Enable Optimize Shading" has been defaulted to "on" and checked.
